SPACE SHUTTLE ORBITER REUSABLE SURFACE INSULATION
FLIGHT RESULTS

Robert L. Dotts, James A. Smith, and Donald J. Tillian
NASA Johnson Space Center
Houston, Texas

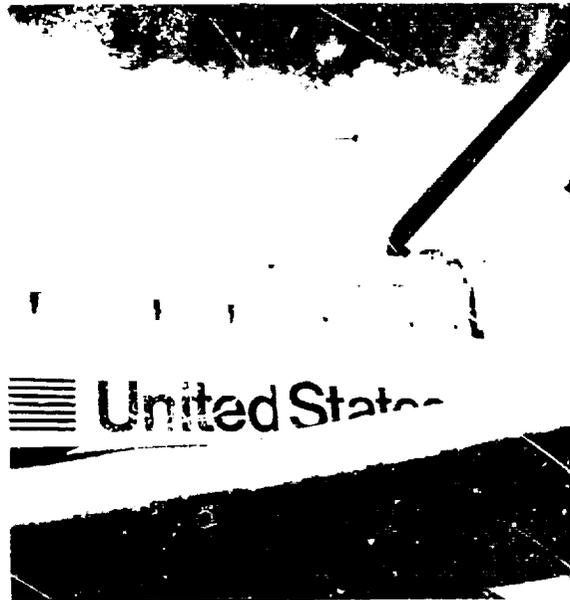
Figure 6.- Overtemperature areas of FRSI on payload bay door - STS-1.

Sufficient data has been acquired to describe the primary aerothermodynamic characteristics of the orbiter configuration for the conditions under which it has been flown. In general, transition effects have occurred later than expected. The surface temperature distributions and magnitudes that occurred during entry were within expected ranges. However, there were some localized areas where surface temperatures exceeded the design thermal limits of the TPS materials. Figure 5 shows an area of FRSI that experienced overtemperature conditions on the aft side of the OMS Pod. Figure 6 shows an area of FRSI that experienced overtemperature conditions on the side of the payload bay doors.
